# Manhole Inspection Summary

Manhole # S41GG\_029MH

Insp Date: 1/2/08 1:22 PM

**Location** Address: **N DALLAS ST**

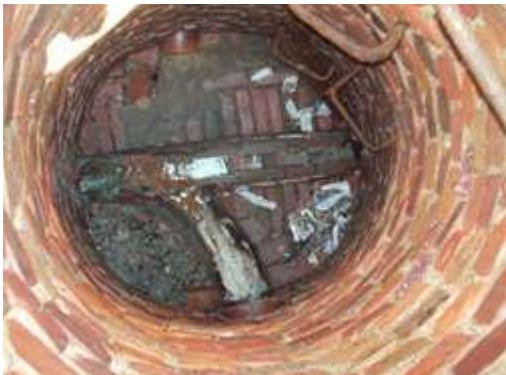
Defect 3

Condition: ☐ Sound ☐ Cracked ☐ Root Intrusion ☐ Deteriorated ☐ Leaks ☒ **Debris**

Debris on bench

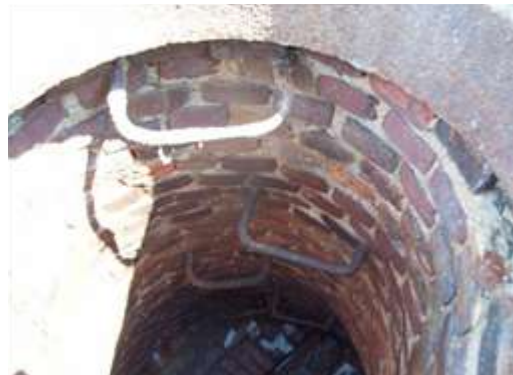
Defect 2

**Steps** Count: **5** Missing: **0** ☒ **Corroded**

Corroded steps

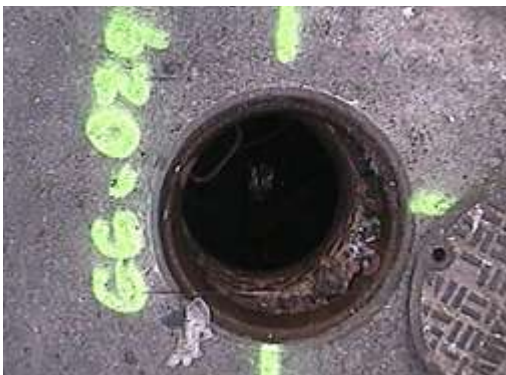
Defect 1

**Frame** Offset: **8** (in.) Condition: ☒ Sound ☐ Cracked ☐ Leaks

Condition: ☐ Sound ☐ Cracked ☐ Root Intrusion ☒ **Loose Brick** ☐ Deteriorated

frame offset and loose bricks at frame Adj.

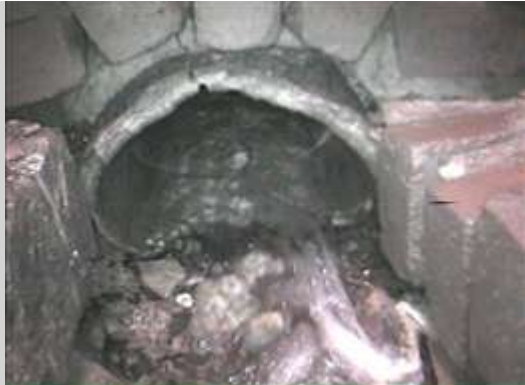
12 O'Clock Outflow

Comments **ALL THREE PIPES ARE CRACKED**

PIPE CRACKED

Infiltration: **None** Pipe Seal Cond: **Cracked**

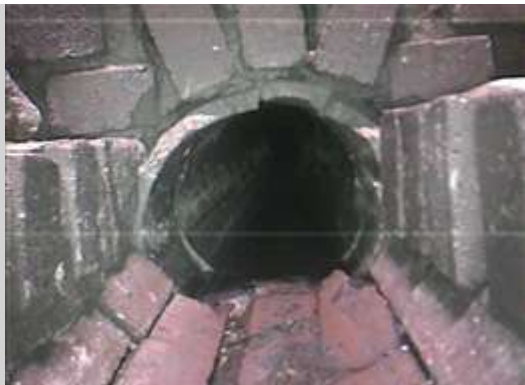
6 O'Clock Inflow

Infiltration: **None** Pipe Seal Cond: **Cracked**

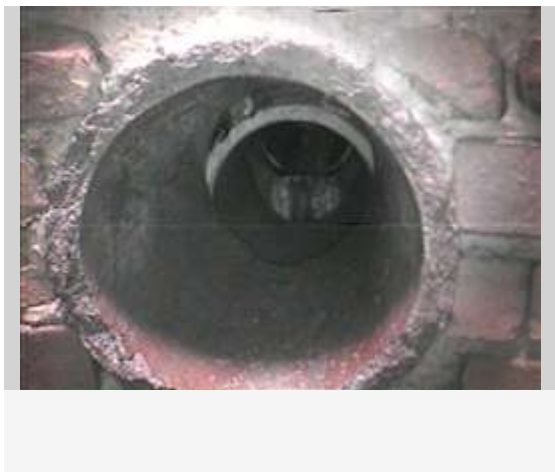
9 O'Clock Inflow

Pipe Height: (in.) Direct  
Pipe Material: **Clay** ☐ Pipe Lined  
Invert Depth: **6.61** (ft.) Flow Characteristics: **Slow**  
Deposits: ☐ None ☐ Mud ☒ **Sludge** ☒ **Debris** ☐ Grease  
Silt Depth: **3** (in.) Deposits Extent: **Light**  
Infiltration: **None** Pipe Seal Cond: **Cracked**
